NACA TN 2991

TECHNICAL NOTE 2991

ACCELERATIONS AND PASSENGER HARNESS LOADS MEASURED  
IN FULL-SCALE LIGHT-AIRPLANE CRASHES

By A. Martin Eiband, Scott H. Simpkinson  
and Dugald O. Black

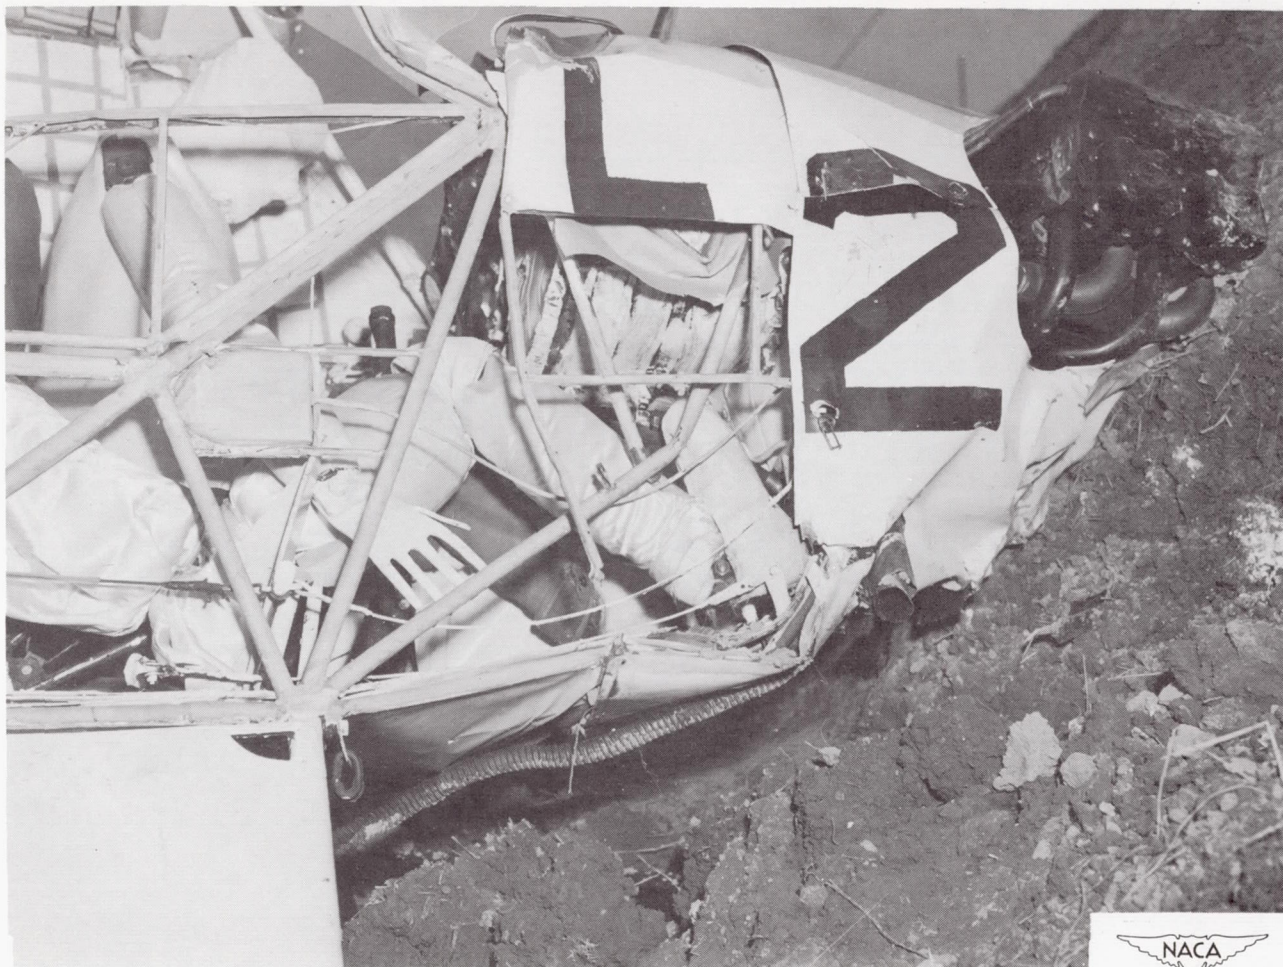
(b) Impact speed, 42 mph.

The front dummy in the 60-mph crash also struck the instrument panel in the same manner as illustrated for the 42-mph crash. The front dummy in both crashes then bounced back into the normal seated position as shown by the post-crash photographs of the 60- and 42-mph crashes in figure 16. These figures, when compared with the photograph of an undamaged airplane (fig. 3), also illustrate the reduction in distance between the front dummy and the instrument panel. The post-crash front-cockpit clearance decreased as impact speed increased.

The fuel-spread pattern (fig. 21) of the 60-mph crash reveals a heavy concentration of fuel around the engine, throughout the cabin, and over approximately 66 percent of the under surface of the right wing. The fuel spillage within the passenger compartment and on both dummies, if ignited, would have completely inflamed their clothing. In the two crashes in which a dummy was installed in the front seat, the manner in which its foot was pinned in the wreckage indicates that, if fire were to occur, a human occupant in the same position would experience extreme difficulty in extricating himself before fire enveloped the entire airplane. Figure 16 shows the front dummy's foot pinned between the fire wall and the right-side removable diagonal brace.

Figure 16. - Concluded. Position of parachute dummy in front seat of airplane after crash.

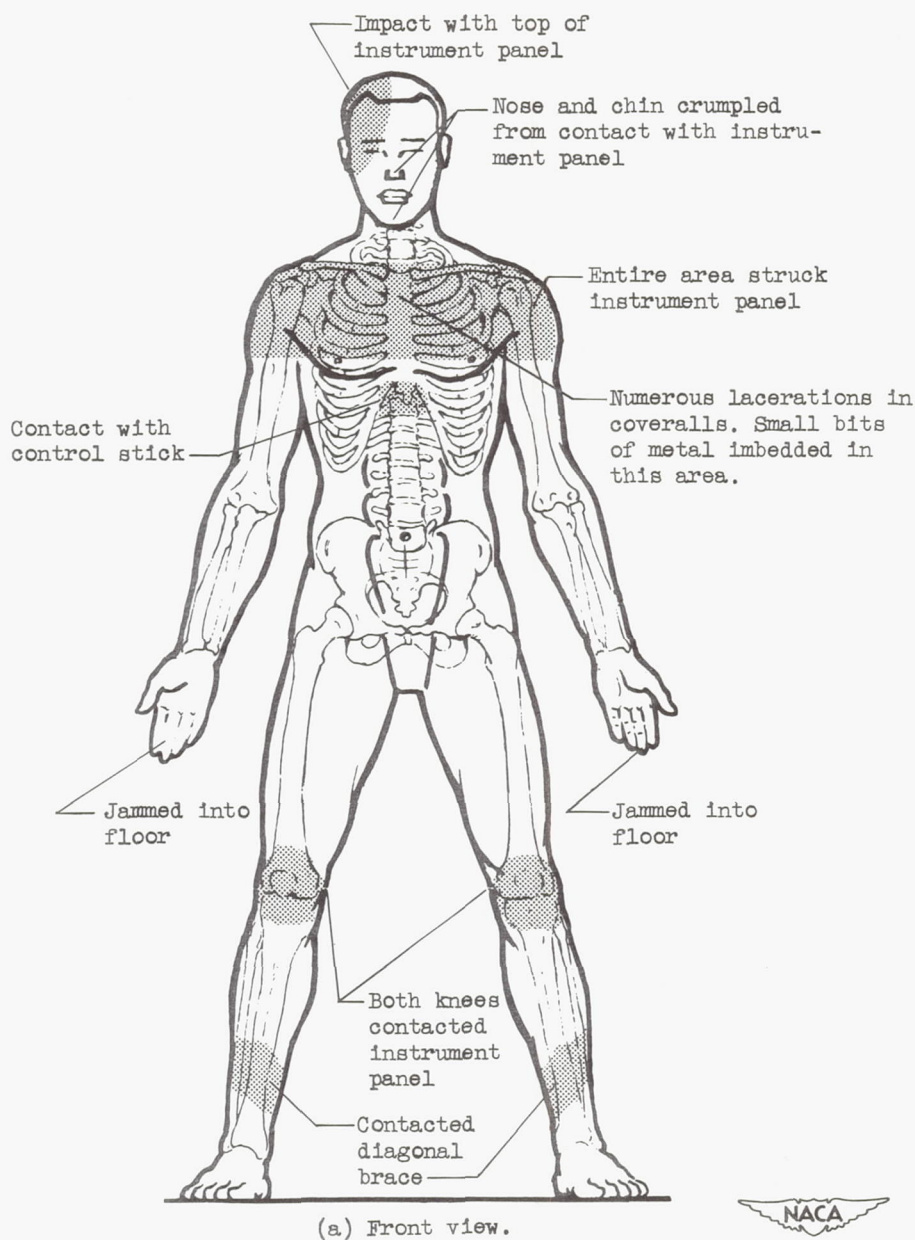
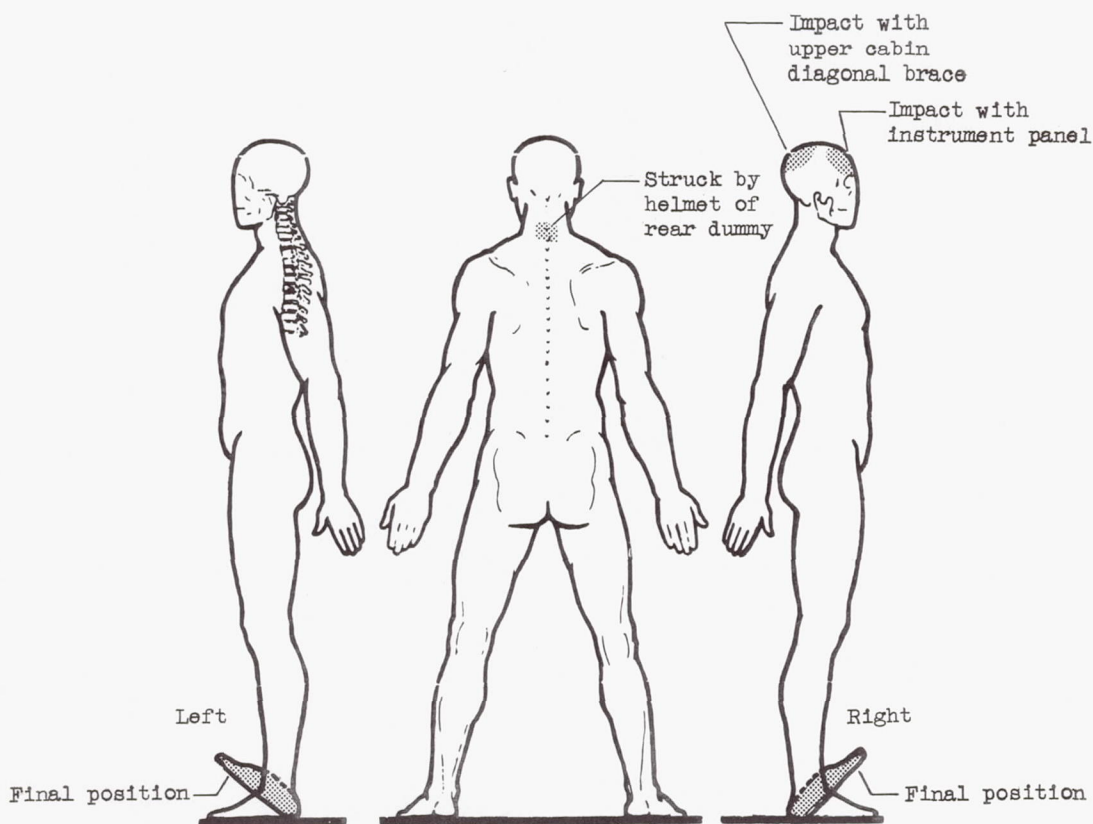
Figure 17. - Location, area, and cause of blows sustained by front-seat dummy in 60-mph crash.

Figure 17(a) is a front view of the dummy, indicating the location and the areas of contact in the 60-mph crash. Contact of the head with the instrument panel was of sufficient intensity to put permanent creases in the heavy canvas covering of the dummy's head. The head struck the top of the instrument panel over the two areas indicated in figure 17(a) and left the dent in the instrument panel as shown in figure 16(a). The right-side view of the head in figure 17(b) shows the area over which the head contacted the upper right cabin diagonal brace on the rebound. Contact of the chest with the face of the instrument panel over the area indicated (fig. 17(a)) was of sufficient force to imbed numerous pieces of metal in the felt-fabric covering of the dummy. Definite contact with the control stick was indicated in the position shown in figure 17(a). Final position of the control stick with respect to both the dummy's chest and the instrument panel is shown in figure 16(a). This figure also shows the final position of the knees jammed into the bottom edge of the instrument panel. Figure 17(a) indicates areas on the knees of the dummy that were cut and torn by this contact. Abrasion marks on the cloth covering of the dummy's lower legs indicate contact with the lower-cabin removable diagonal braces. The final position of both feet in figure 17(b) indicates the severe flexure of both ankles in the crumpled forestructure, while the back view shows the area on the back of the neck struck by the helmet of the rear dummy.

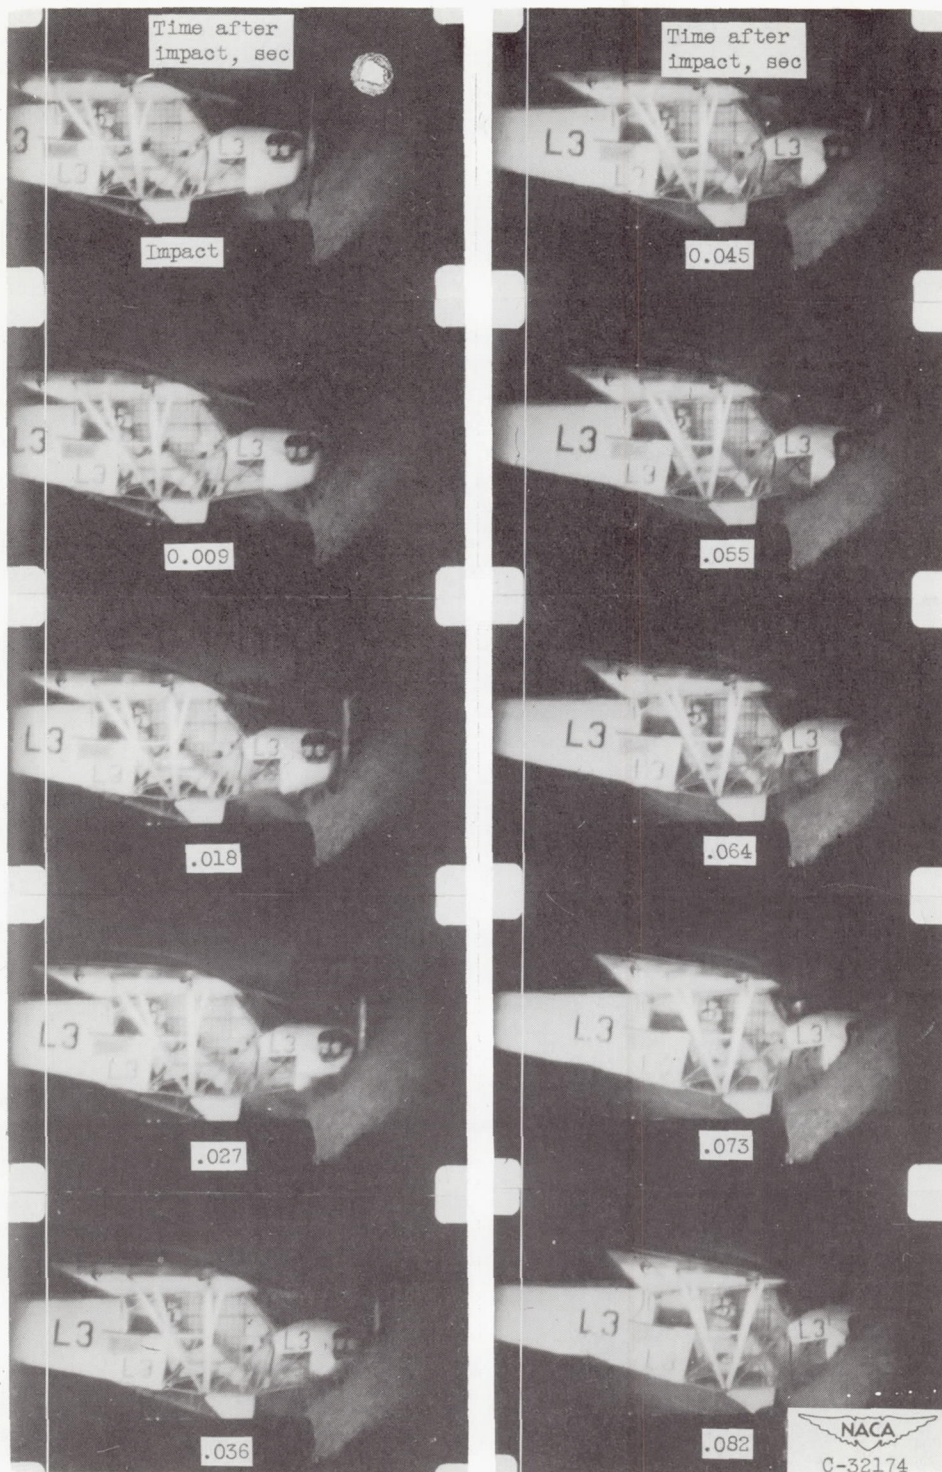
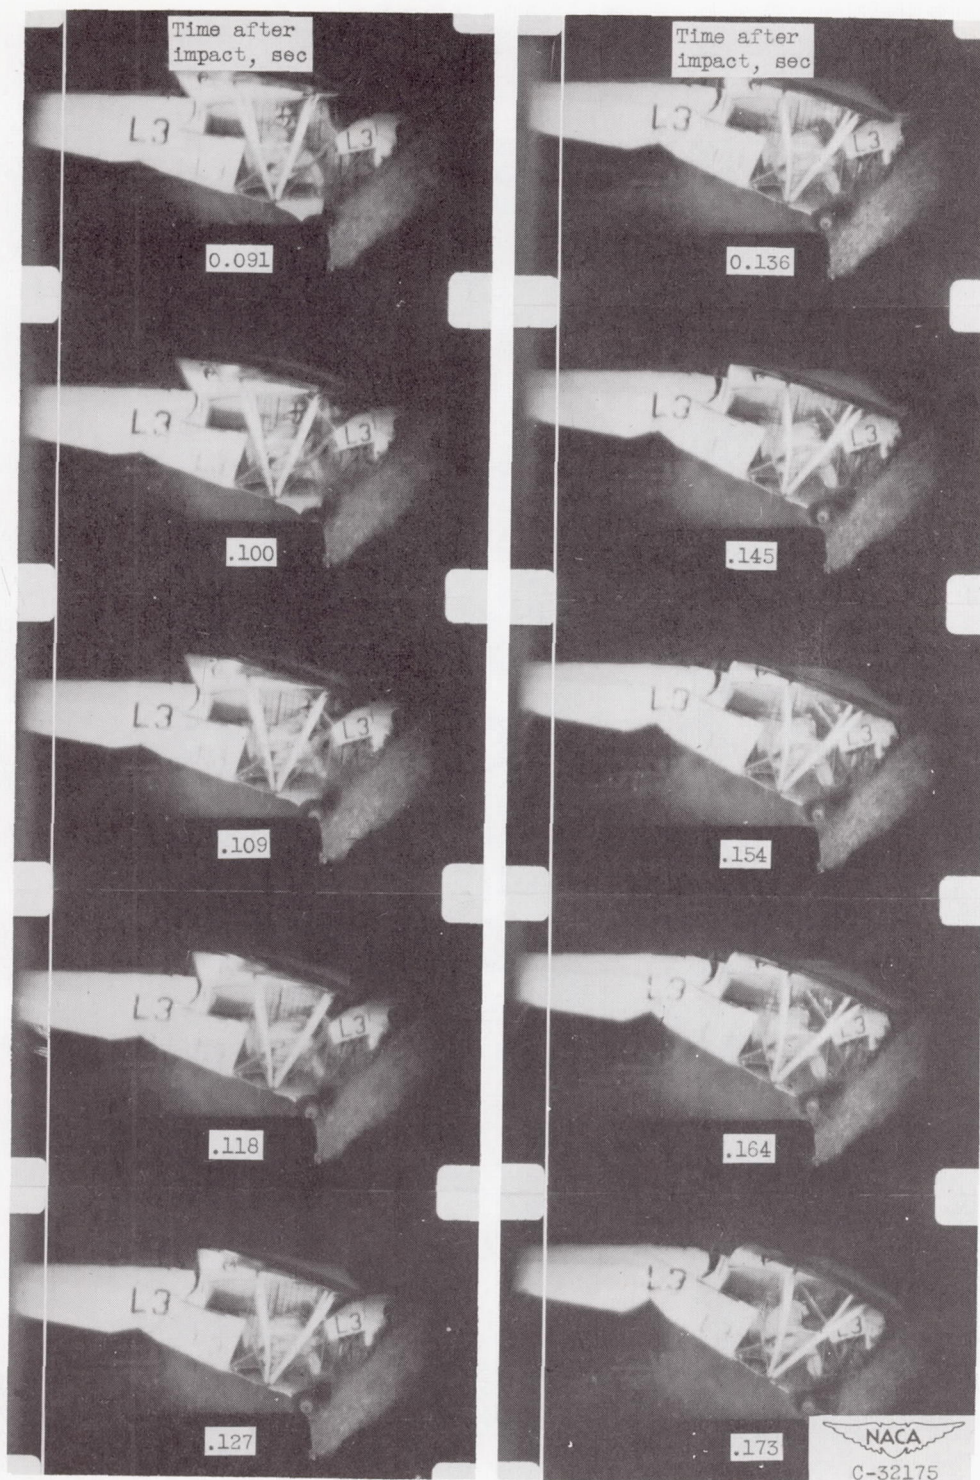
Figure 18. - Displacement of airplane and rear dummy during deceleration in 47-mph crash.

Bodily contact with structure (seat belt only). - In order to investigate the sequence of events during displacement of the torso around the seat belt, the anthropomorphic dummy was installed in the rear seat with only seat-belt restraint in the 47-mph crash. To provide unlimited movement of the torso about the seat belt, the front seat and the rear control stick were removed. Photographs in figure 18 of the 47-mph crash show the movement of the dummy forward out of its seat, followed by rotation of the torso about the seat belt. Without the control stick and the front seat to limit the movement of the torso and the head, the torso rotated forward and downward until the chest contacted the thighs at 0.118 second after impact (fig. 18(b)). The distance through which the torso and the head swung around the seat belt into the area forward of the dummy was approximately the length of the torso from the hips to the top of the head. It is apparent from figure 18 that, if injuries resulting from contact with solid structure are to be avoided when using only seat-belt restraint, the estimated distance of 31 to 45 inches (ref. 7) forward of the seat must remain free of any solid, sharp, or unyielding protuberances.

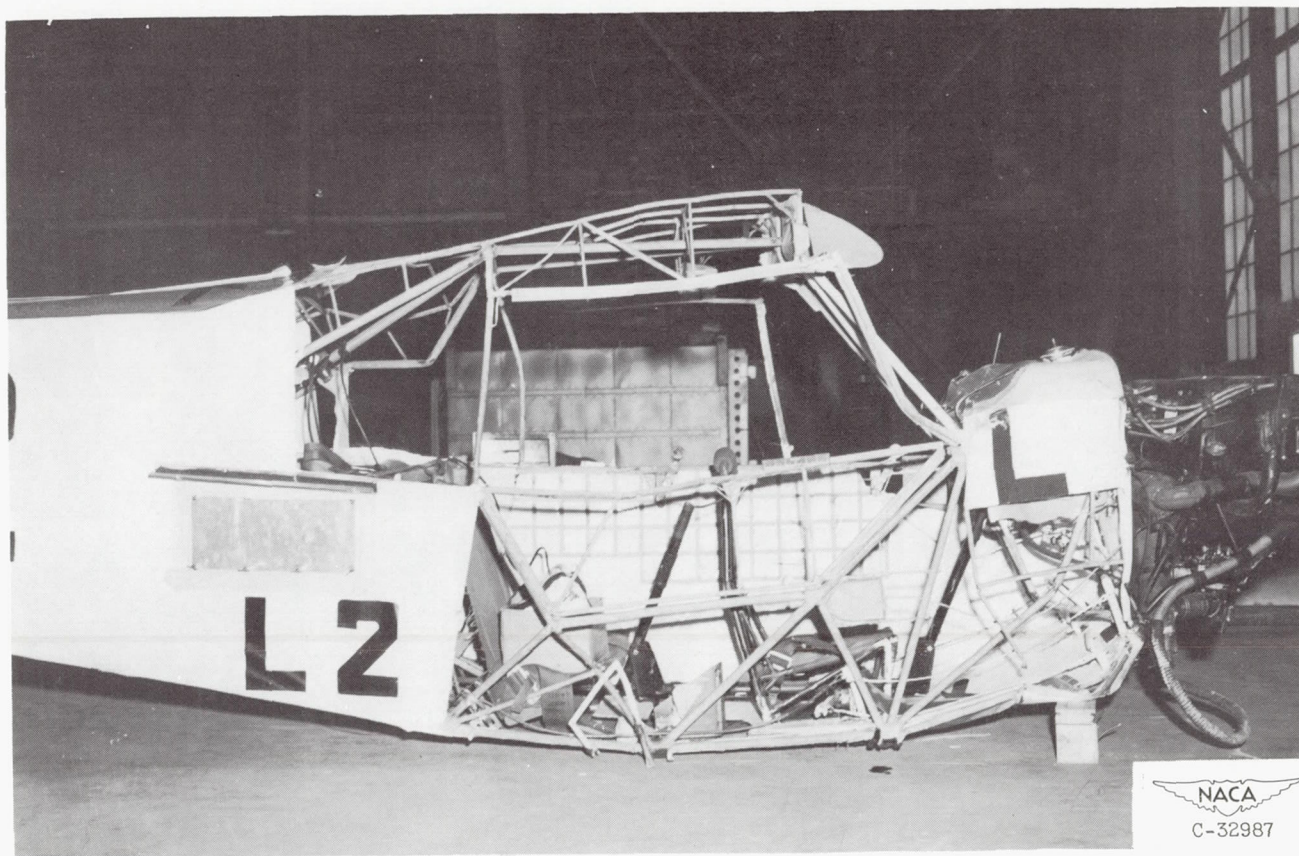
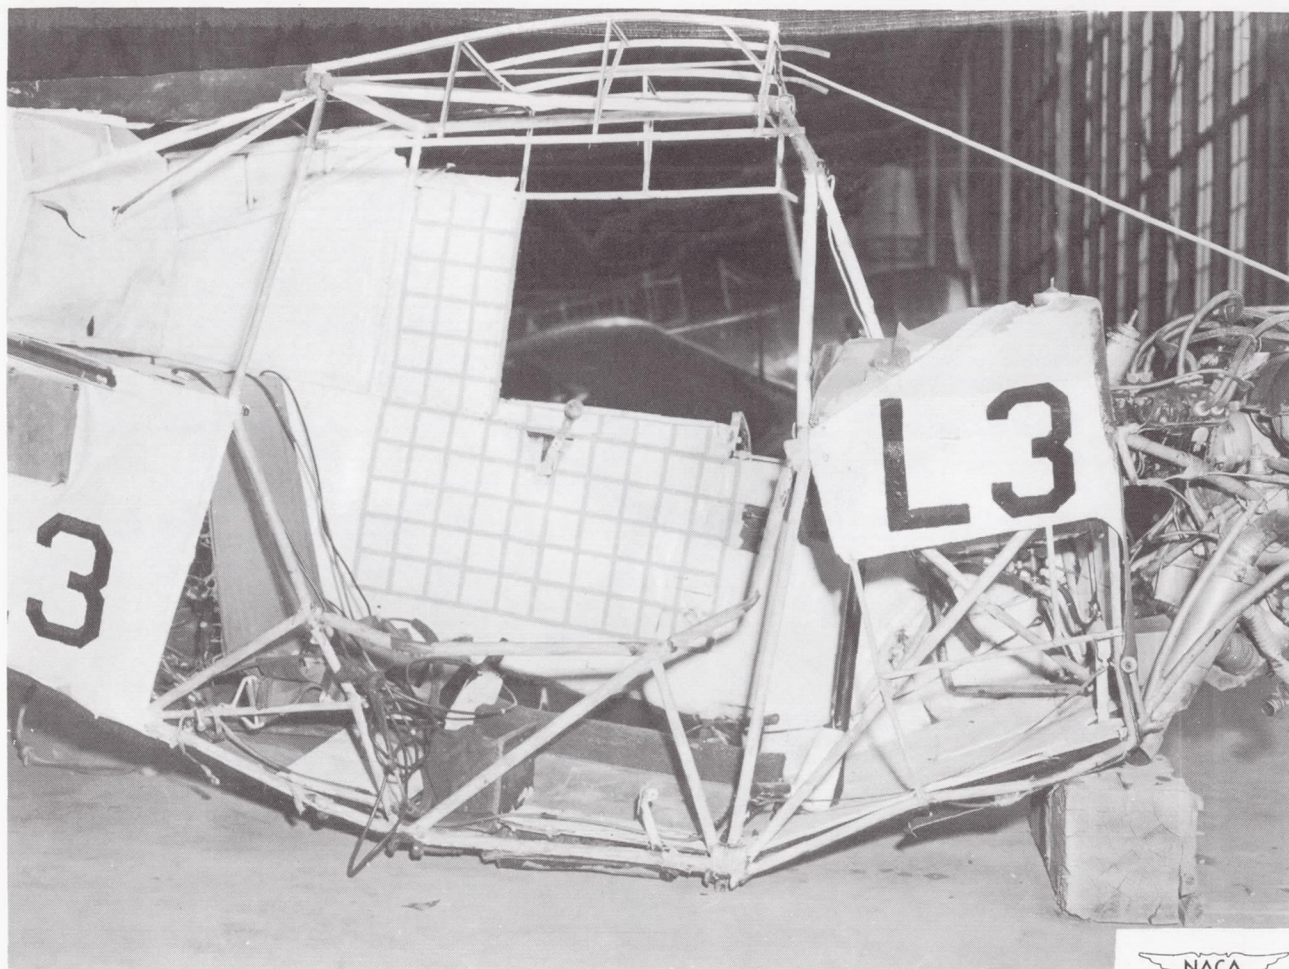
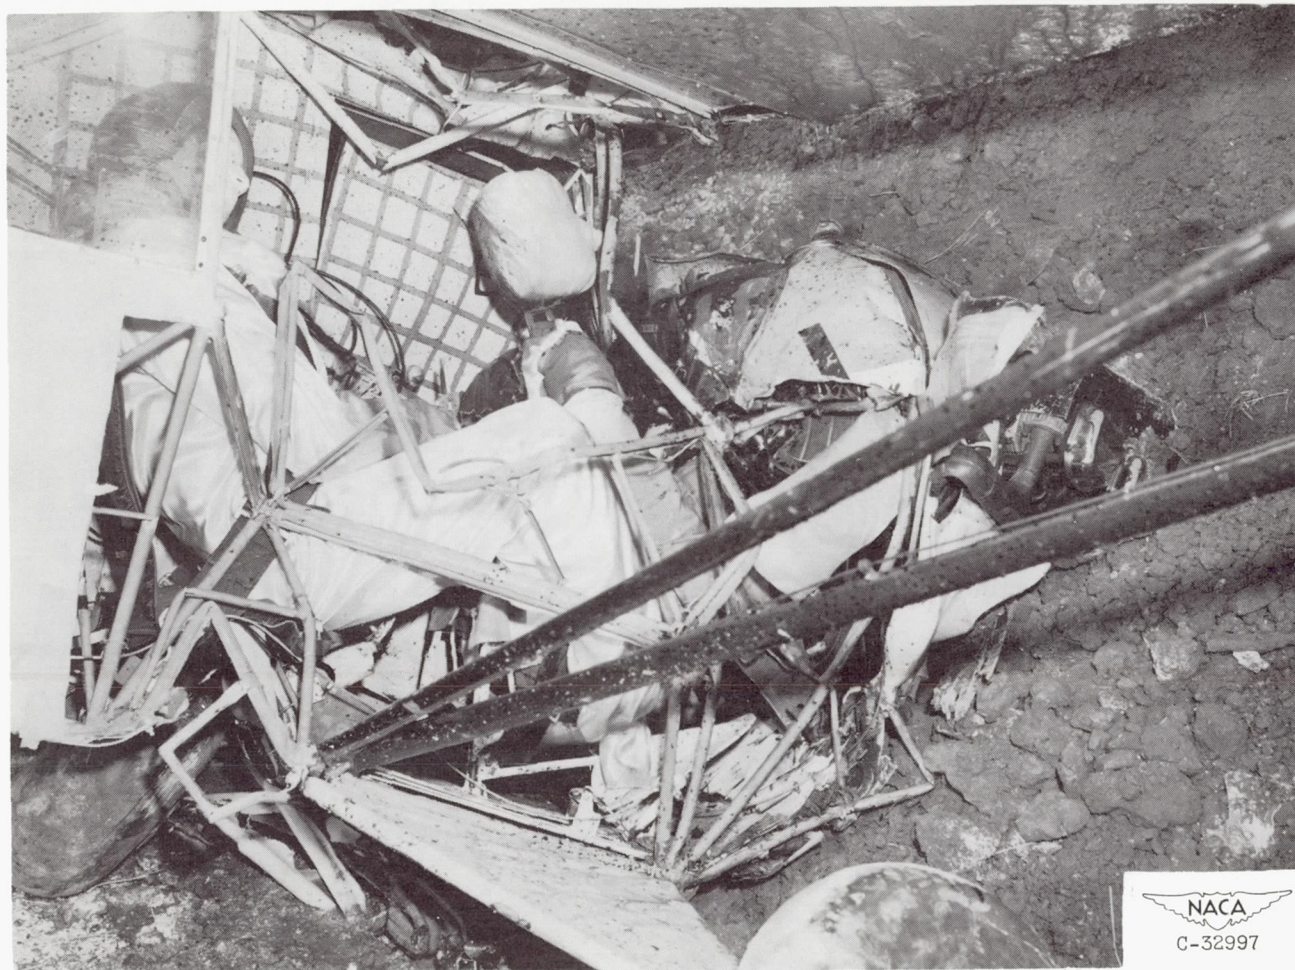
Figure 19. - Crash damage to airplane structure.

Collapse of cabin structure. - Potential injury of the occupants due to inward-collapsing cabin structure is indicated by comparison of the extent of the collapse of the cabin structure in figure 19. The figures show photographs of the cabin area following the 42-, 47-, and 60-mph crashes. As indicated by comparison of these photographs, an increase of speed at impact with the barrier caused a corresponding reduction of the volume enclosed by the cabin structure. Figure 19(a) shows that, during the 42-mph crash, deformation of the cabin was minor. Appreciable reduction in cabin volume was noticeable with an increase of impact speed to 47 mph. During this crash, the cabin volume was reduced by the rearward displacement of the instrument panel, as may be detected by comparing the position of the upper, forward, right-side diagonal brace in figure 19(b) with its undistorted position after the 42-mph crash, figure 19(a). With an impact speed of 60 mph, considerable reduction in cabin volume resulted. This reduction resulted from (1) rearward movement of the instrument panel nearly to the front dummy's chest and (2) collapse of the longerons under the rear seat (fig. 19(c)). Distortion of the cabin structural tubing during cabin deformation may increase the probability of injury to the occupants. An example of this distortion is shown by the upper cabin members projecting into the proximity of the heads of both dummies in figure 19(c). It is evident from inspection of figure 19 that, if occupants of an airplane during a crash are to be protected from the additional hazard of striking the deformed cabin structural members collapsing around them, the cabin structure itself must be strong enough to resist the decelerative forces occurring at impact.

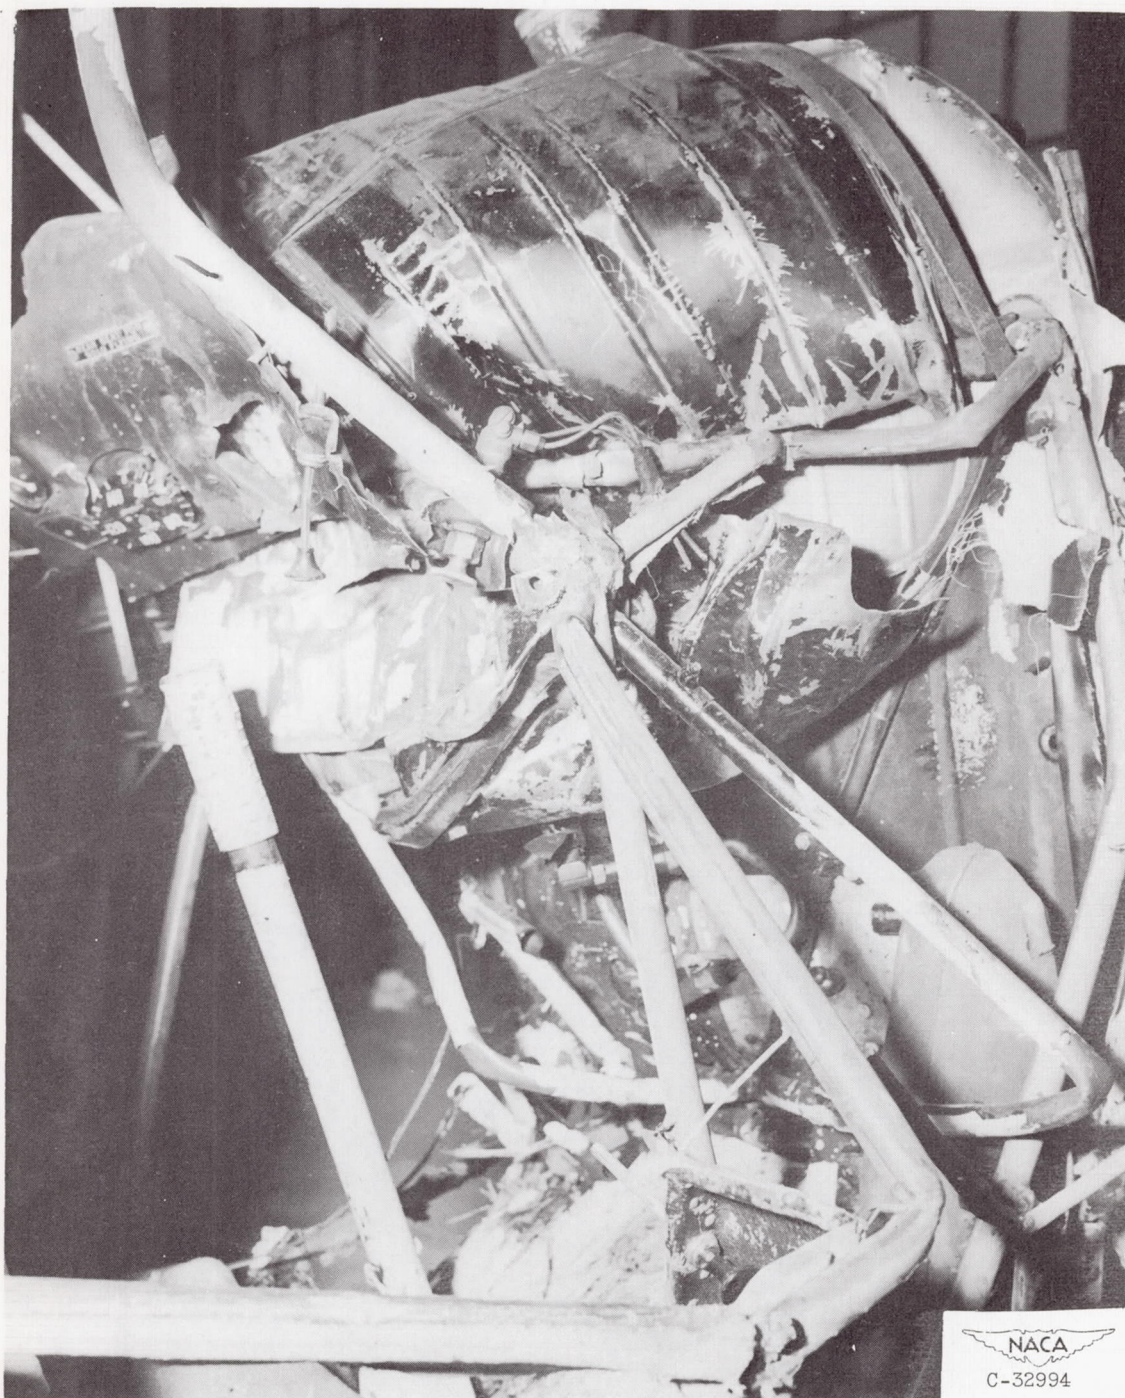
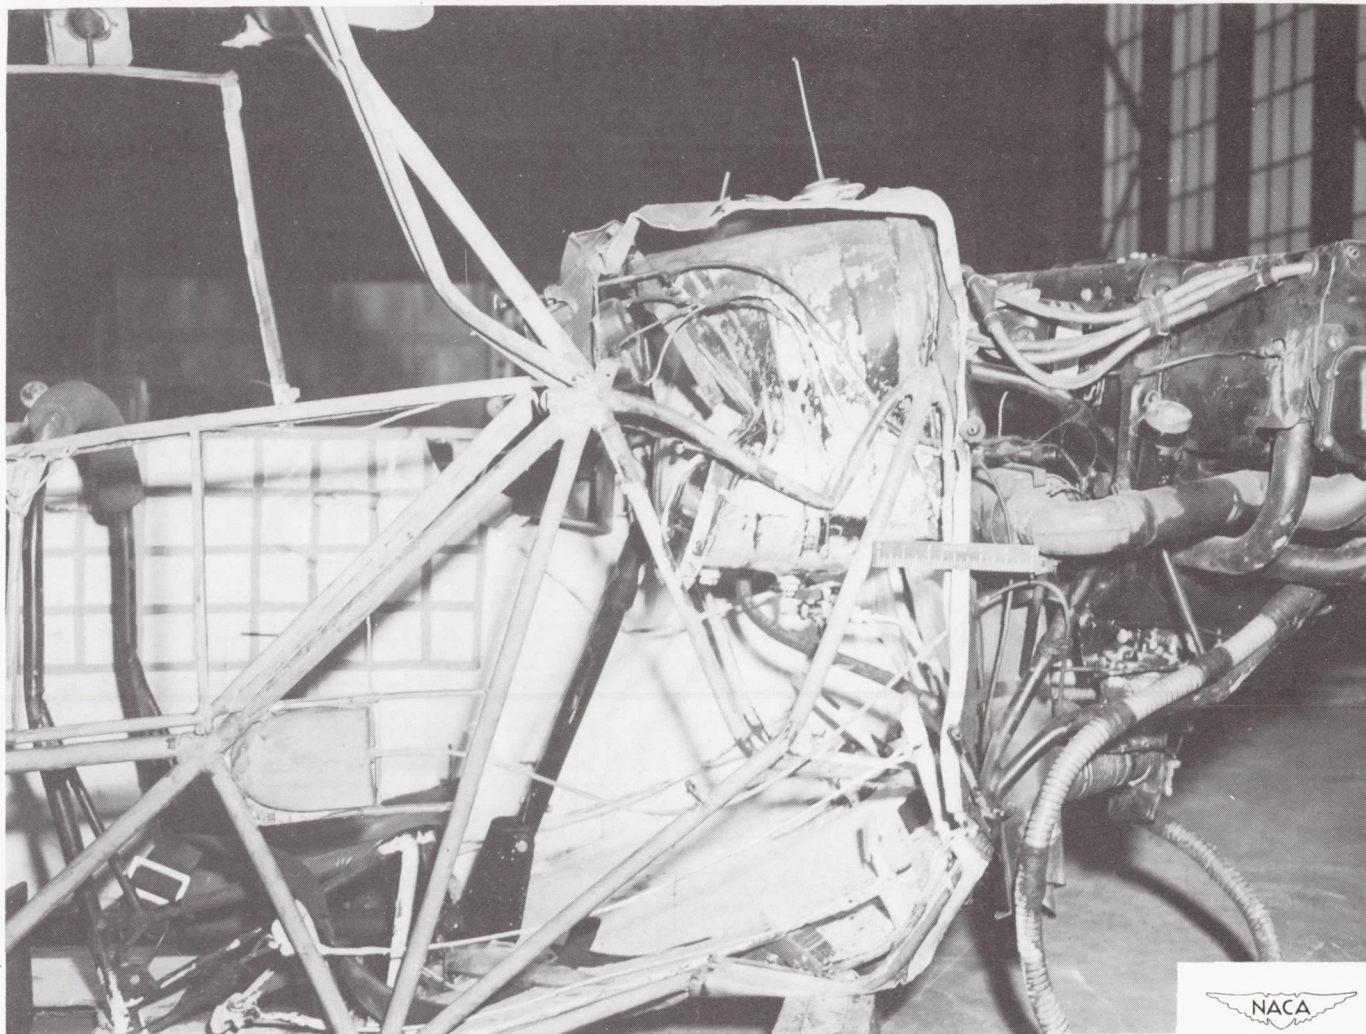
Figure 20 shows the damage to the fuel tank in the 60- and 42-mph crashes. In each crash the fuel tank was crushed between the fire wall and the instrument panel. In the 60-mph crash, the tank was burst at the seams and the sheet metal was torn open by hydraulic loading. The tank was compressed to one-half of its original volume in the crash. Figure 20(b) shows that the empty tank was only deformed and crushed, with no bursting of the seams and no tearing of the parent sheet metal, in the 42-mph crash.

Figure 20. - Extent of damage to full fuel tank during a crash.

Figure 20. - Concluded. Extent of damage to empty fuel tank during a crash.
